A Critique of the Architecture of Faculty of Science Complex, University of Lagos, Nigeria

Adewale Segun Alabi*

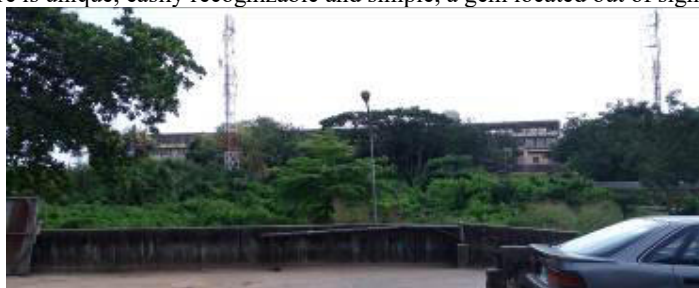
Plate 1: North approach view (Source: Author, 2016)

The main entrance is situated at the mid-section of the longitudinal north elevation, although not pronounced, it is raised to allow free flow of air within the building synonymous to Le Corbusier's approach to modern architecture permitting stack effect. Promoted as new architecture, Le Corbusier described it in his book "*Vers Une Architecture*" published 1923, translated as *Towards a New Architecture* (1927), in which he celebrated amongst other things the beauty and adventure associated with ocean going liners (Le-Corbusier, 1923).

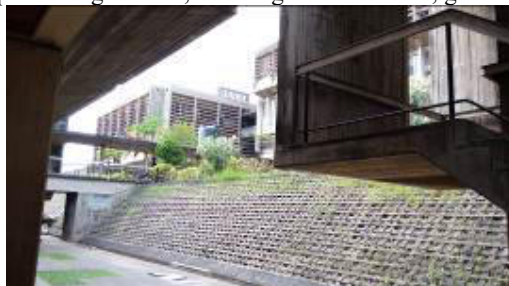
Plate 2: Concrete retaining walls with basket weave appearance perforations (Source: Author, 2016)

The retaining walls serve a great function in holding up the sloping terrain towards the south and also serve as the basement floor. The gardens create good scenery for passersby. The natural landscape considered in the design of the retaining walls cushions the hardness imposed by the massive concrete of the building. However, over time, the original intention of keeping the gardens within the courtyard area green has somewhat been encroached upon with the unguided intrusion of some services such as indiscriminately installed pipes and water tanks.

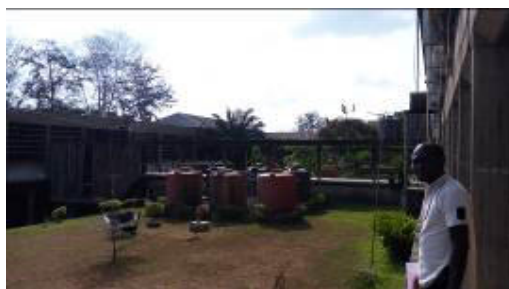
Plate 3: Courtyard area encroached upon with unguided intrusion of some services (Source: Author, 2016)

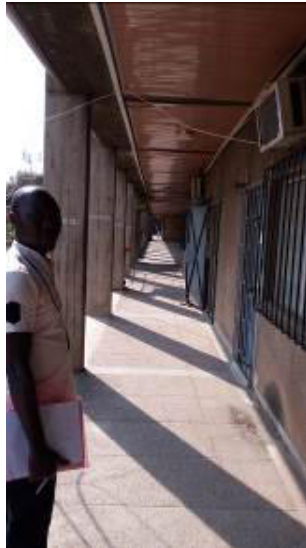
The design was intended to make maximum use of ventilation in order to have an adequate micro-climate by applying good orientation of the structure and the introduction of sun shading devices which would also act as funnels guiding air into the structure. It appears that this was not fully achievable because of the presence of air conditioners dotting the structure in an obviously unplanned arrangement. These ACs are fitted into any conceivable available space such as the roof and windows. The need for these mechanical coolants is probably due to the ability of concrete to absorb and conduct heat in large quantities thus making rooms hot despite constant flow of natural air. The interior spaces had been originally insulated with the use of wood panels which

over time were stripped away and replaced with PVC panels which do nothing about insulation. Small wonder, the heat gain of the building required a mechanical solution.

Plate 4: ceiling replaced with PVC panels (Source: Author, 2016)

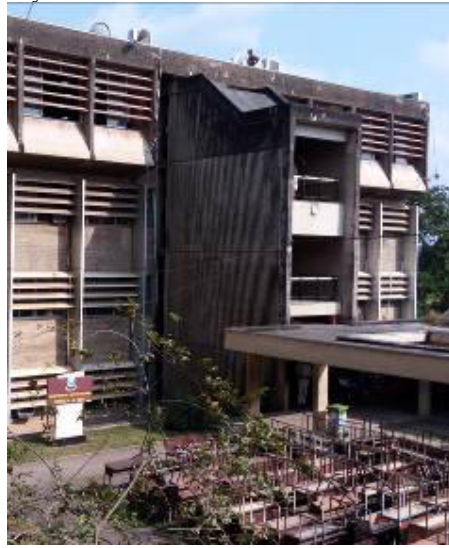
Conversely, the installations were not properly and neatly carried out, which now gives the façade of the building a deformed look especially where outlets have been drilled on the parapet walls and units mounted on windows and wall surfaces in an unsynchronized manner.

Plate 5: Drilled parapet walls for AC piping (Source: Author, 2016)

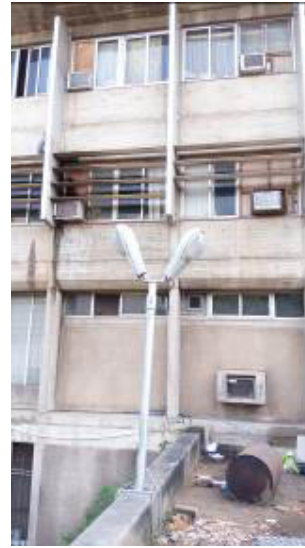
Plate 6: Units mounted on windows and walls in a haphazard fashion (Source: Author, 2016)

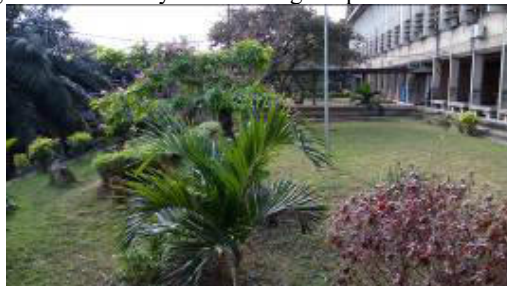
Plate 7: Courtyard Garden, defining the portions between the links (source: author, 2016)
